CHAPTER 12

FLASHINGS AND APPURTENANCES

Section I. WALL, CHIMNEY, AND MONITOR FLASHINGS

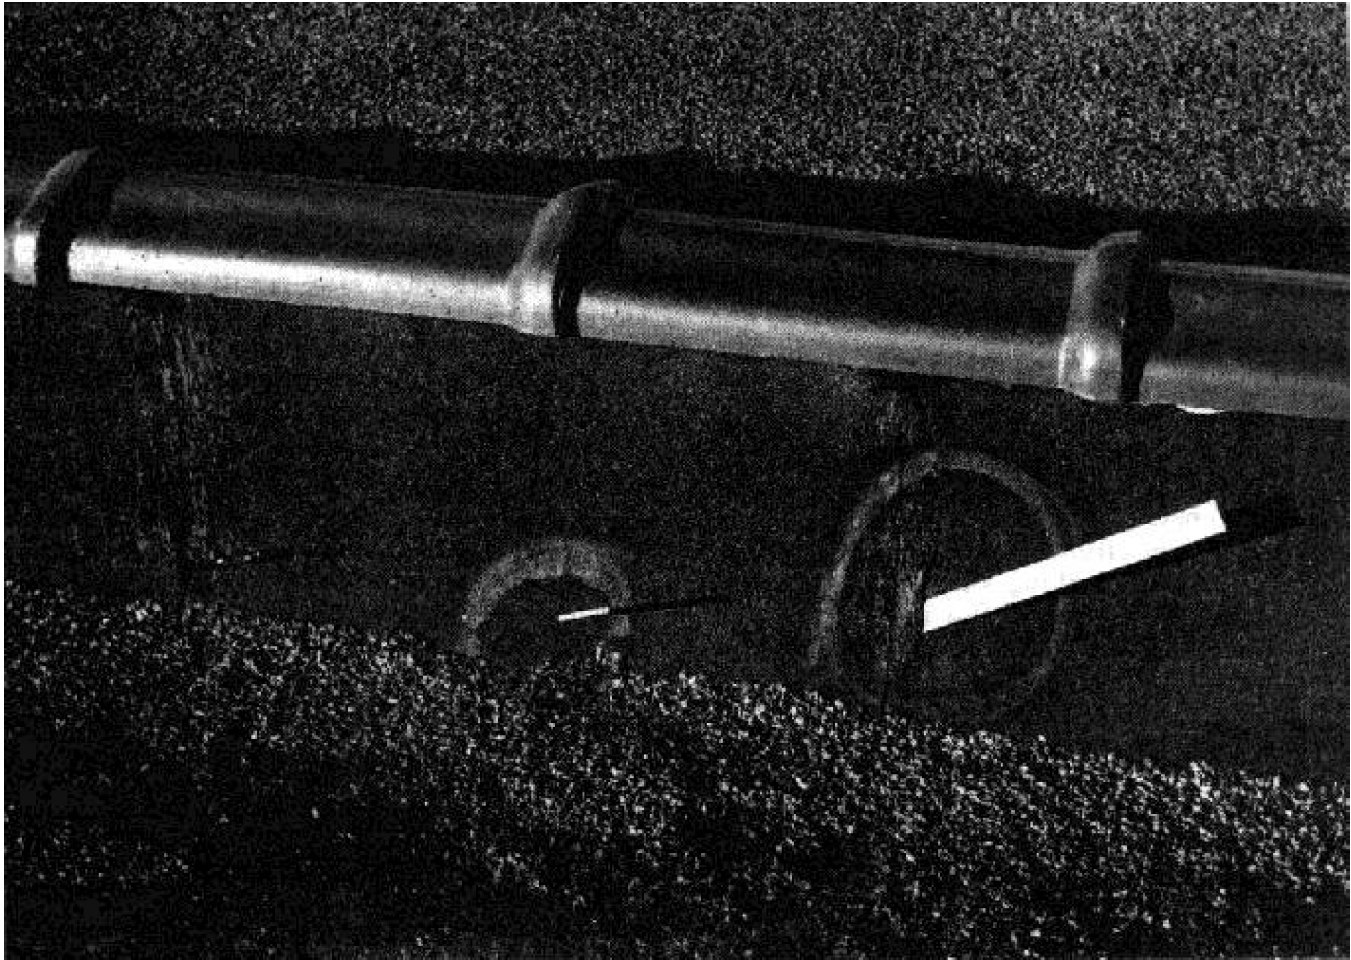
Figure 49. Open laps and split in base flashing..

- (1) Weathering resulting from insufficient or lack of protective coating.
- (2) Punctures usually resulting from the omission of a cant strip (fig. 48).
- (3) Open laps or seams (fig. 49).
- (4) Separation of flashings from vertical surface.
- (5) No allowance made for expansion and contraction of metal flashings.
- (6) Damage by personnel having access to roofs.
